AFWAL-TR-87-4086

NONDESTRUCTIVE EVALUATION OF CARBON-CARBON COATINGS

D.C. Copley
GE Aircraft Engines
1 Neumann Way
Cincinnati, Ohio 45215

Final Report for Period August 1984 - February 1987

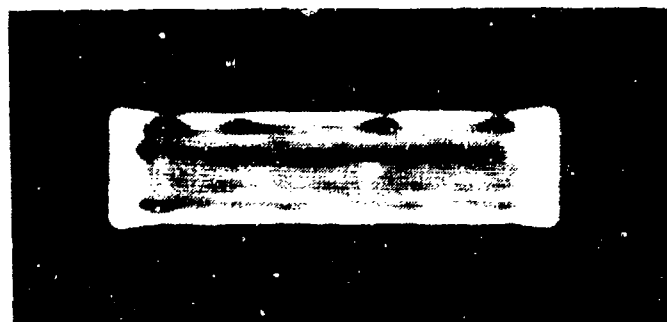
Figure 42. X-ray CT Cross-Sectional Images of Specimen
ACCRI 16 Al₂O₃ Oxidation Cycle.

Note: Same Sections Shown
Metallographically
in Figure 41.
